## TECHNICAL BULLETIN: 13-04

**SUBJECT:** RL2000 Main Board Failure Diagnosis

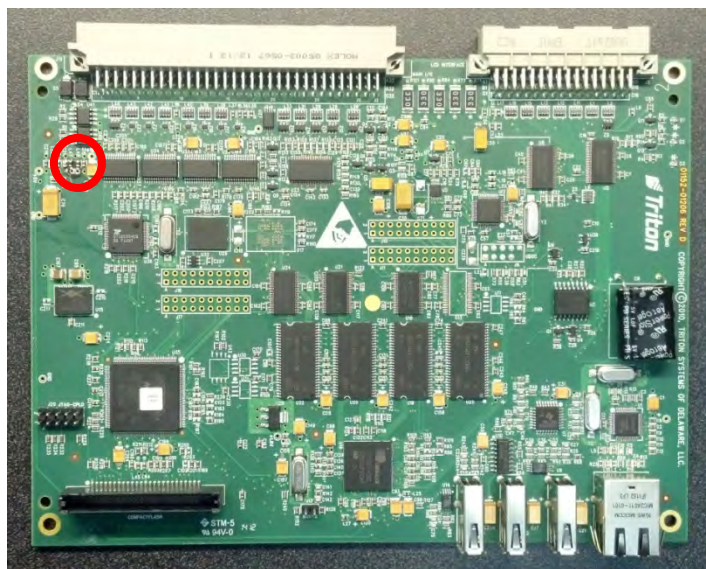
This technical bulletin is to provide field technicians with a method of determining the possible cause of a RL2000 main board failure. If the main board fails in a RL2000 with an 8" LCD, you should examine the inductor at L47 for signs of damage.

*Location of L47 on the Main Board Used in the RL2000*

If L47 is damaged, both the main board and the inverter must be replaced. Replacing the main board only will not resolve any field issues and will likely result in a second main board failure.
