TECHNICAL BULLETIN: 13-07

DATE: March 8, 2013

SUBJECT: Possible Defective Modem Chip used on Triton Traverse and RL/FT Products

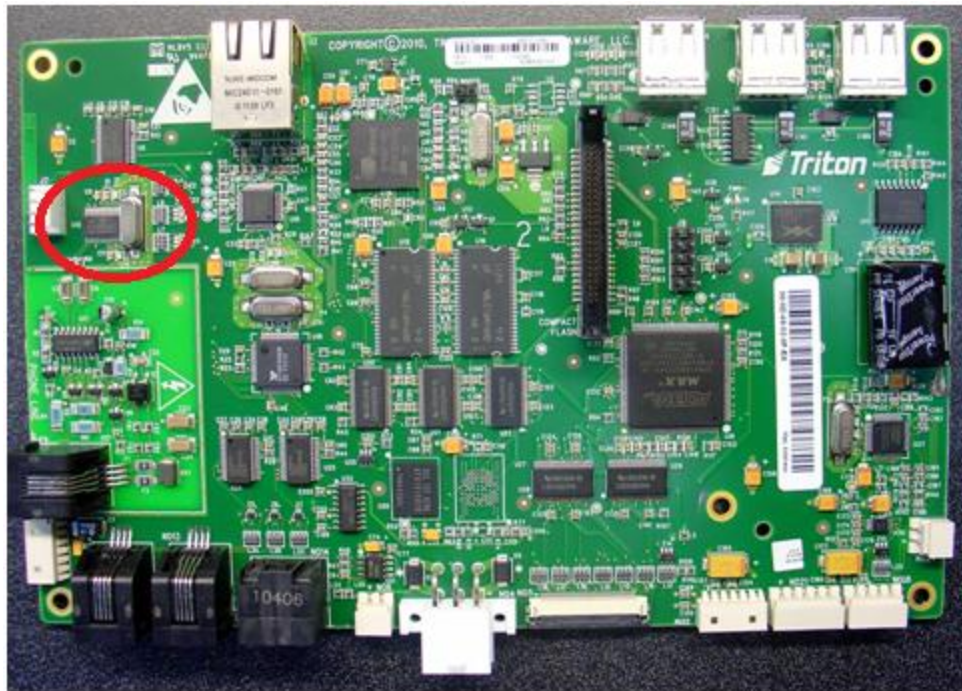
Location of the modem chip on Traverse

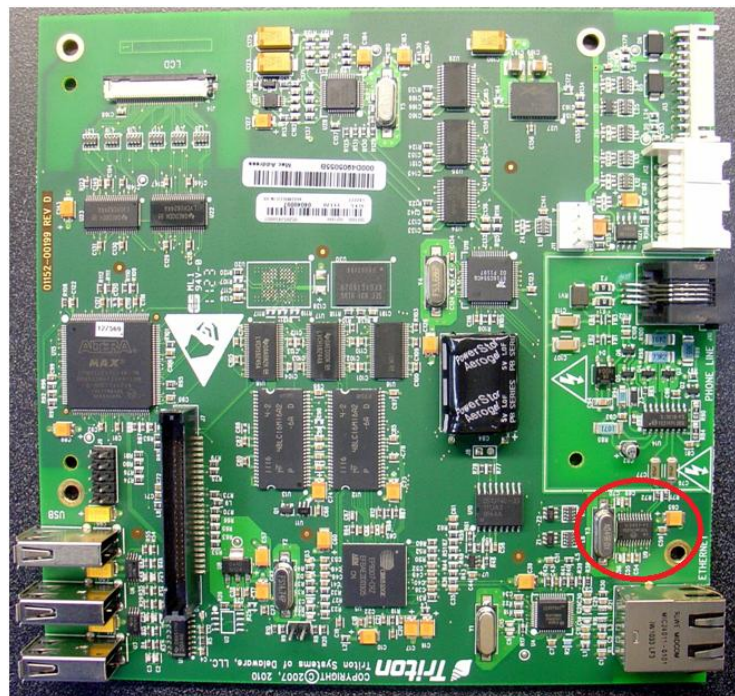
Location of the modem chip on the RL1600

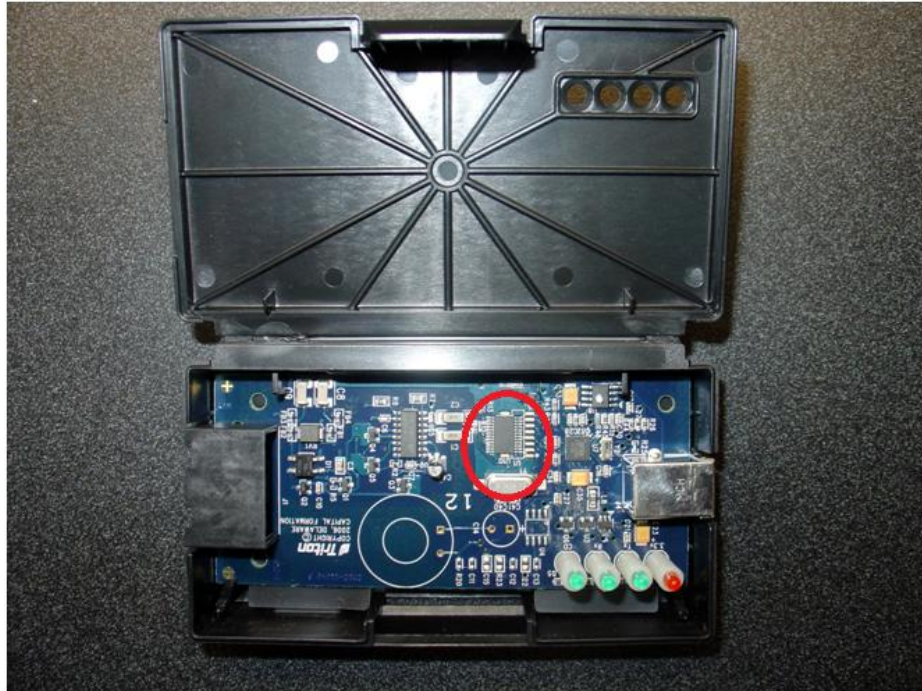
Location of the modem chip in the USB Modem (used in RL2000, RL5000, RT2000 and FT5000)

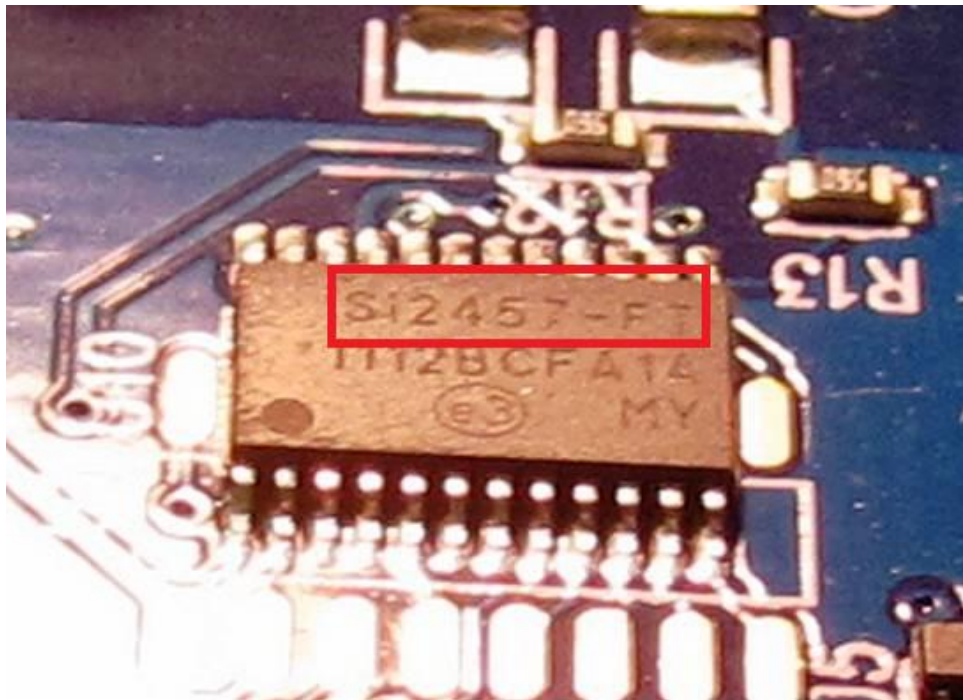
The modem chip is stamped with part number Si2457.

Location of the modem chip part number Si2457

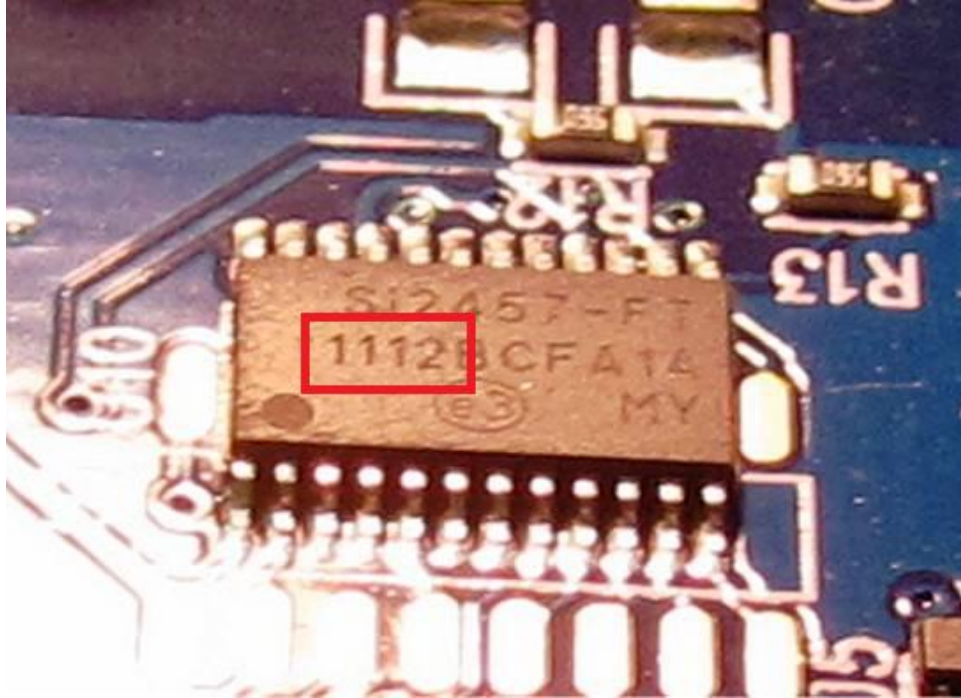
Triton has discovered that defective modem chips may have been used on products produced since February 2012. These products include the Traverse, RL1600, and the USB modem used on the RL2000, RL5000 and FT5000. Part sales may also have been affected.

A date code is printed just below the part number. If the date code is 1112, then the chip is from the defective lot.

Modem chip showing date code from the defective lot (1112)

Triton will replace main boards or modems with the defective chip. Please contact Triton Customer Service or place orders through ATMGurus for a 13 month warranty replacement.

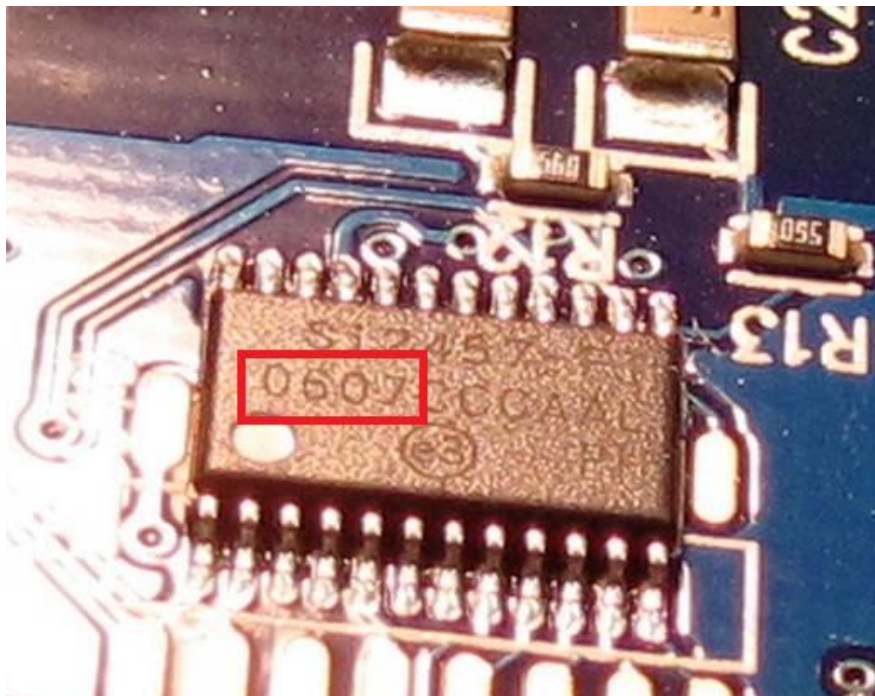
Modem chip showing date code which is not from defective lot (anything other than 1112)

If you are experiencing excessive communication failures and your modem does not have the defective chip, please call Triton Technical Support for assistance.
