TECHNICAL BULLETIN: 13-24

DATE: August 28, 2013

SUBJECT: [X2 Docking Board Dip Switch Settings](#)

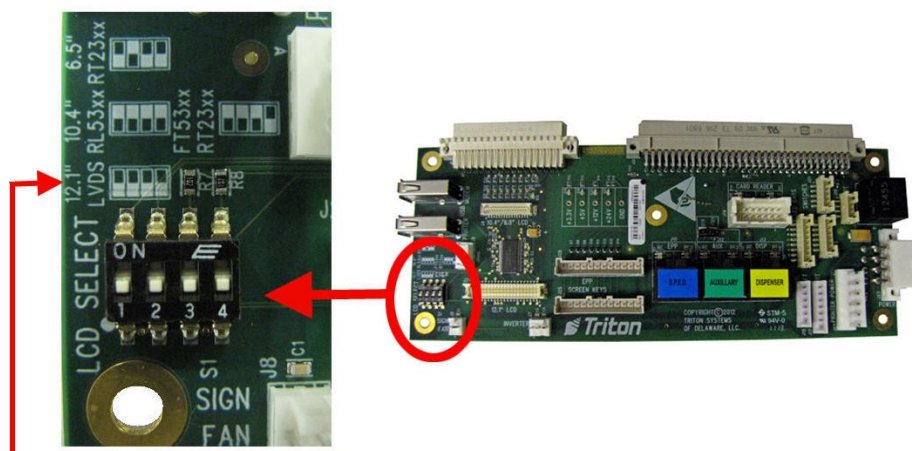
The previous board had 5 dip switches to set. The new board only has 4 dip switches. To avoid confusion, a guide has been printed directly on the board showing to how to set the switches depending on the unit configuration.

(photo above shows the switches set for the 12.1" display, all switches in the OFF position)

With the introduction of the ARGO unit, Triton is combining inventory and reducing the unit specific parts available. All the RL53 are now being built with docking board [09100-00153](#). The Docking Board Assembly **#06200-00159** is no longer available; instead order part **#09100-00153**. The new board is backwards compatible however there is a slight change in the Dip Switches.
