## TECHNICAL BULLETIN: 14-12 (Revised)

**DATE:** April 23, 2014 - **Revised:** January 30, 2015

**SUBJECT:** New PCI PTS POI v3.1 T9 EPP Keypad and Supporting Software

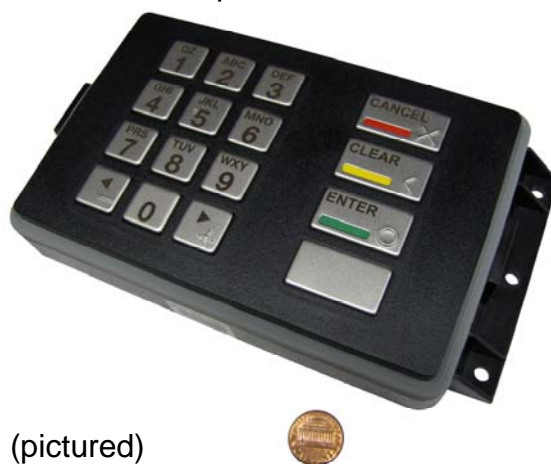
09200-20050 UK T9 EPP Keypad  
09200-20150 US T9 EPP Keypad (pictured)  
09200-00250 Canadian T9 EPP Keypad

The T9 is a drop in replacement for new units manufactured with a T5 or T7 EPP Keypad. No additional parts are required. All RL1613, and ARGO were manufactured with T5 or T7 EPP. All X2 RL23XX, RL53XX, FT53XX, and RT23XX were manufactured with T5 or T7 EPP beginning January 2, 2008 (Julian date of 08002). Software must be updated to 3.3.2 before the T9 EPP is installed and activated.

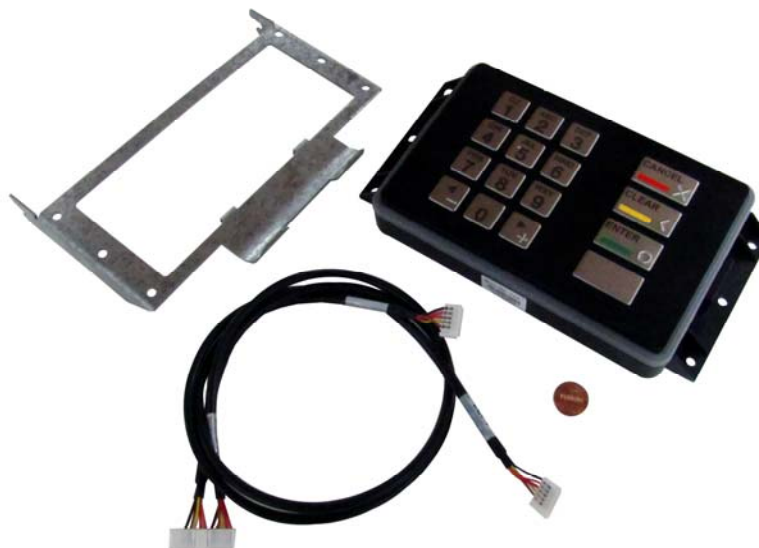
06200-00257 T9 Upgrade Kit, RT2 US (pictured)

If the ATM has been updated from VISA T1 EPP to T7 or needs to be updated from a VISA T1 EPP, the following kits are available. All Xscale RL51XX, RT21XX, and FT51XX were manufactured with VISA T1 EPP beginning December 29, 2004 (Julian date of 04363). Software must be updated to 3.3.2 before the T9 EPP is installed and activated.

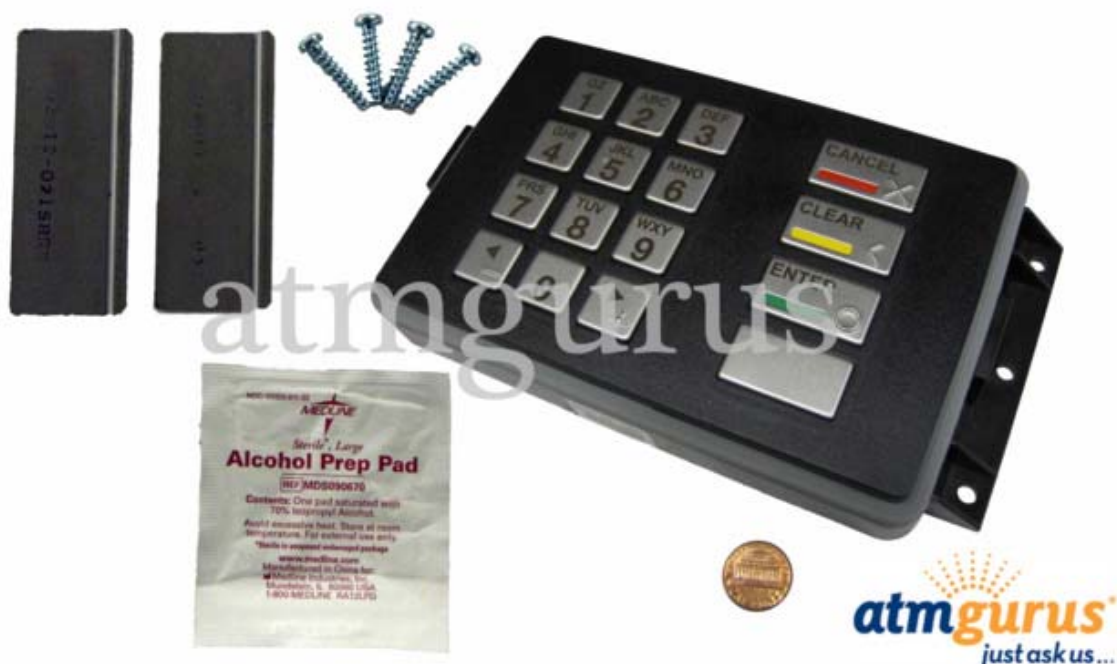
06200-20150 Kit, T9 Upgrade for Traverse US (pictured)  
06200-20250 Kit, T9 Upgrade for Traverse Canada

For Traverse, a hardware kit is necessary due to pressure switches. The following Kits are available to upgrade Traverse to T9.

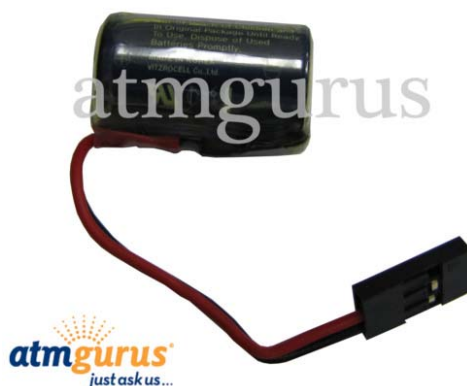
01300-00025 T5 & T9 PCI EPP Lithium Backup Battery

The field replaceable battery is the same as the T5. Triton Part Number 01300-00025 is available for field replacement.

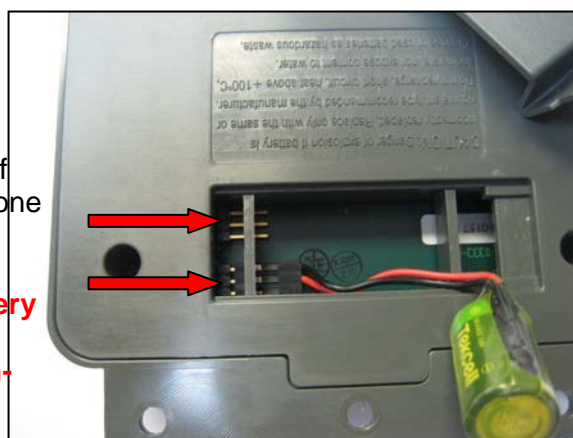
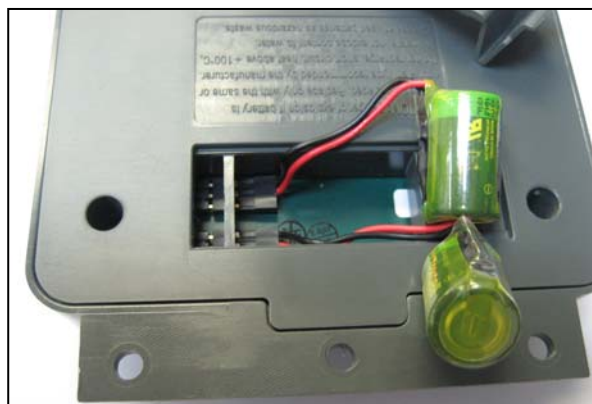
Inside the battery box you will find two sets of battery contacts with a battery connected to one set.

**CAUTION: You must not remove the battery from the EPP until the second battery is connected. The EPP be permanently damaged if unpowered and the battery is removed.**

Plug the replacement battery into the second set of contacts.
