TECHNICAL BULLETIN

TECHNICAL TIP: 15-05

SUBJECT: SDD Datum Rollers' Position

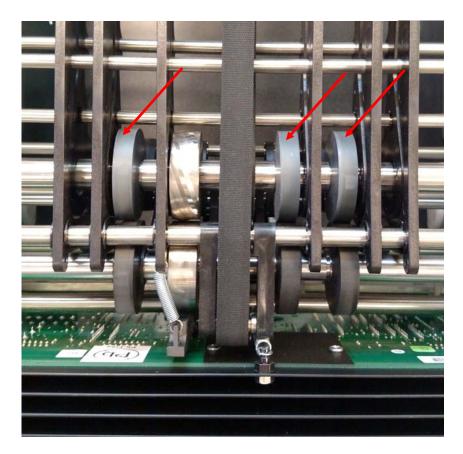
Figure 3 - Datum Rollers

If a SDD is experiencing Error Code (EC) 42 Timing Wheel Error, EC 48 Excessive Rejects, or actual jams, then the first step is to verify you are using ATM fit currency and notes are loaded correctly. The next step in troubleshooting should be to inspect the three datum rollers' position in reference to their grooves on the datum roller shaft.

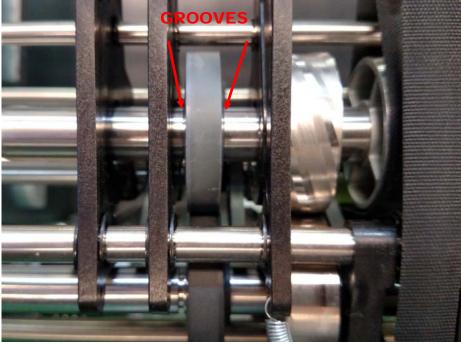
Figure 2 - Correct Position of Datum Roller

The three datum rollers should be centered between their location grooves on the datum roller shaft.

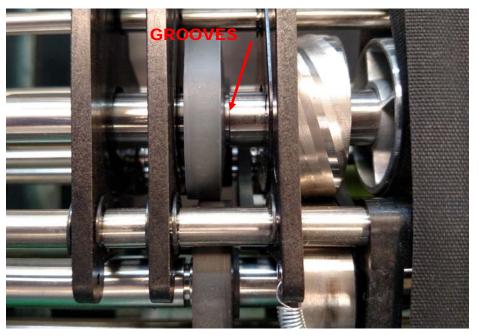
Figure 3 - Incorrect Position of Datum Roller

If the three datum rollers are not properly located between their location grooves on the datum roller shaft, they could cause false rejects or jams during bill transport.

If any datum roller is not in the correct position, please make the simple adjustment described below:
