SUBJECT: Release of Software Version 4.0 with Windows CE 6.0 operating system for ARGO 7, <u>ARGO 12</u>, FT5300, RL5300, RT2300, and RL2300 with 8" and 10.4 display. (Revised)

TECHNICAL BULLETIN: 15-07 (Revised) DATE: June 4, 2015 Revised: July 28, 2015

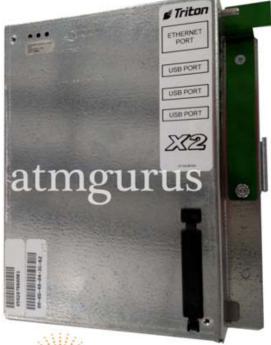
Windows	CE Version: 5.0.1400.20
Startup	Stage 1 Version: 2.2.0.1D
Startup	Stage 2 Version: 2.2.0.1D

<u>Note:</u> The CE version shown above cannot be updated.
