**SUBJECT:**  
**REQUIRED T9 FIRMWARE UPDATE**

**TECHNICAL BULLETIN: 17-17**  
**DATE: OCTOBER 31, 2017**

### REQUIRED FIRMWARE UPDATE FOR ALL T9 EPPS

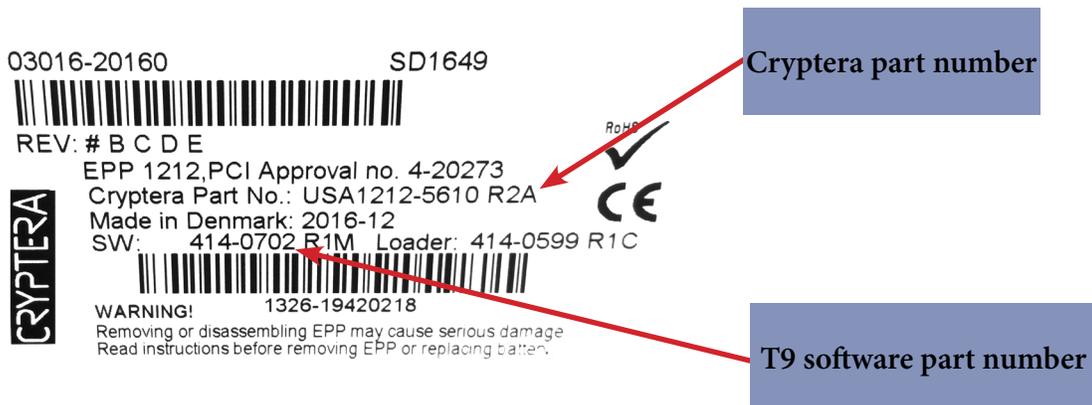
Before loading firmware update, verify EPP is a T9 model and not a T5. All T9 EPPs have a software part number of 414-0702 on the label.
