TECHNICAL BULLETIN

SUBJECT:
MULTITECH MODEM PARAMETERS

TECHNICAL BULLETIN: 17-22

DATE: DECEMBER 21, 2017

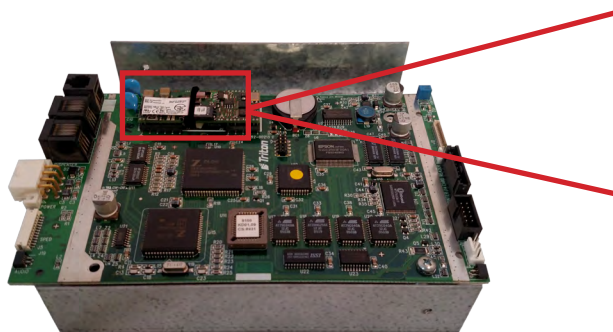
M/N: MT5600SMI
B/O - 34

MultiTech changed the default error control and synchronous mode parameter from 1 to 3. Triton has discovered that this can cause a failure to communicate with Triton Connect when using a Systech modem. Any 81XX/91XX /96XX/97XX ATM equipped with a MultiTech MT56XXSMI modem series with B/O: 34 version should change the initialization string for Triton Connect to +ES=1 to avoid communication issues. Verify modem model, then follow steps below to configure.

1. Navigate to *Management Functions > Configure Terminal > More > Communication > Modem Configuration > Modem Setup String > Triton Connect Call String*.
2. Select **Change**. Terminal will not visually prompt user that it is ready for input.
3. Enter the value: **+ES=1**.
4. Press **Enter** on the keypad to complete configuration.
