TECHNICAL BULLETIN

SUBJECT:
T10 EPP FIRMWARE R2A UPDATE

TECHNICAL BULLETIN: 24-08
DATE: OCTOBER 07, 2024

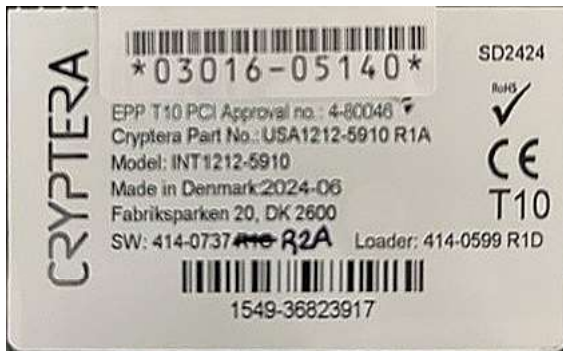
EPP Label

PCI-5 T10 KEYPAD	
USA1212-5910 R1A	Cryptera Part Number
4-80046	PCI Approval Number
414-0737 R2A	SOFTWARE
T10	EPP
