**SUBJECT:**  
**TRITON CONNECT 6.1 SERVICE PACK 2**

**TECHNICAL BULLETIN: 18-12**  
**DATE: SEPTEMBER 06, 2018**

## OPTIONAL SOFTWARE UPGRADE – RELEASE OF TRITON CONNECT 6.1 SP2

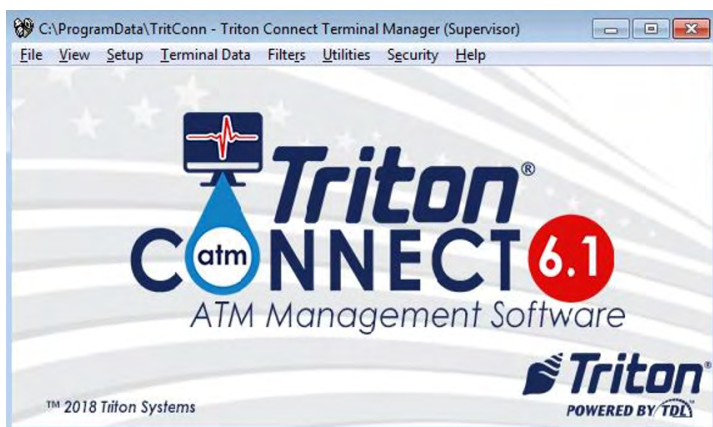
### Triton Connect Terminal Down Time Per Error Report

Triton announces the release of Triton Connect 6.1 SP2. Service Pack 2 includes an updated Terminal Manager graphic and a new downtime report. The downtime report details how long individual terminals are out of service per error code.
