ADDENDUM
9640-SERIES CASH DISPENSER
BCU SHIPPING SPACER
REMOVAL

TDN 07103-00003 04/01

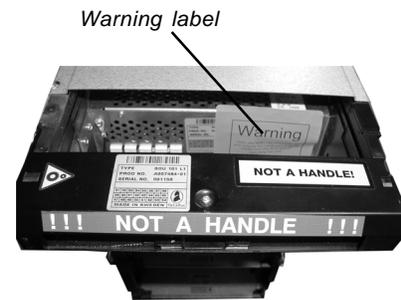
Figure 1. Warning Label.

3. Note the Warning label over the AC input connector and ON/OFF switch located on the front of the dispenser behind the throat, shown in Figure 1. **DO NOT REMOVE THE LABEL AT THIS TIME!**
4. Remove the strip of packing tape that secures the BCU cover, shown in Figure 2. Close the top lid and apply tape across the lid to hold it in place during shipping.
5. Open the BCU cover. Note the cardboard spacer, as shown in Figure 3. Remove the spacer.
6. Replace the BCU cover.
7. Remove the Warning Label over the AC input connector and ON/OFF switch, shown in Figure 1.
8. Slide the mechanism back into the cabinet.

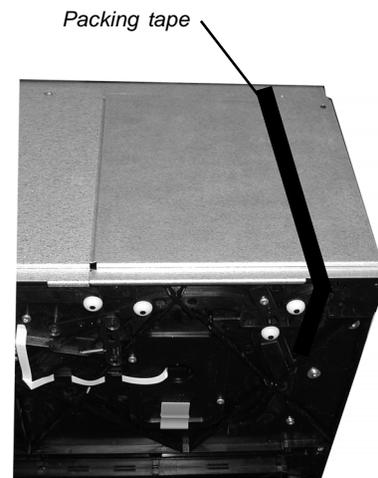
Figure 2. BCU Cover secured with packing tape.

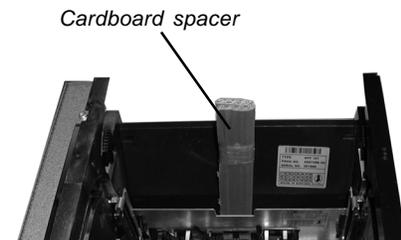
A cardboard spacer is located behind the BCU assembly! This spacer must be removed before using the dispensing mechanism for the first time! Follow this procedure to remove the spacer!

Figure 3. BCU Cover removed and cardboard spacer visible.
