## **TECHNICAL BULLETIN**

SUBJECT:
TLS UPDATES FOR TRITON CONNECT

TECHNICAL TIP: 17-11
DATE: AUGUST 28, 2017

## TRITON TECHNICAL TIP – UPDATING CERTIFICATES WITH TRITON CONNECT

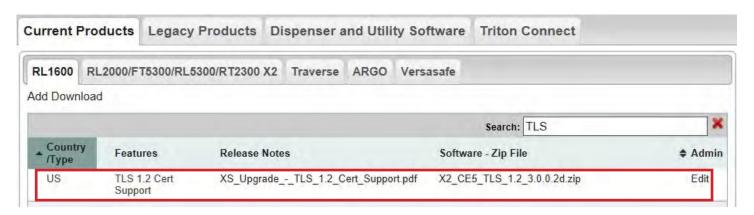
Software must be version 2.4.0 or greater. If the tsocketocx file is version 3.0.0.2 or higher, no further action is required. If tsocketocx is prior to 3.0.0.2, a software update must be performed.

**xu20tsck3.0.0.4.tlf** for Xscale update **t-us-tsck-3.0.0.2d.tr6** for X2 CE6 update

xu30tsck3.0.0.2d.tfv for X2 CE5 update t-us-tsck-3.0.0.2d.tr7 for X3 update
