TDL GATEWAY WIRELESS MODEM INSTALLATION PROCEDURES

TDN 07103-10179

TDL GATEWAY MODEM

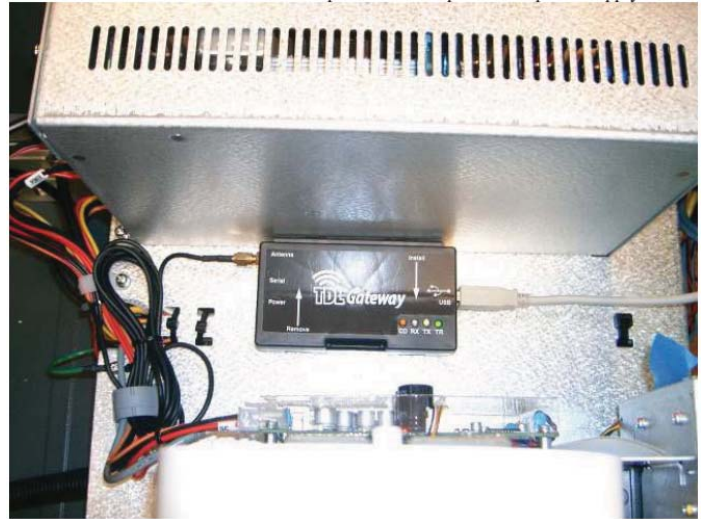
The WM is mounted with double sided tape between the printer and power supply.

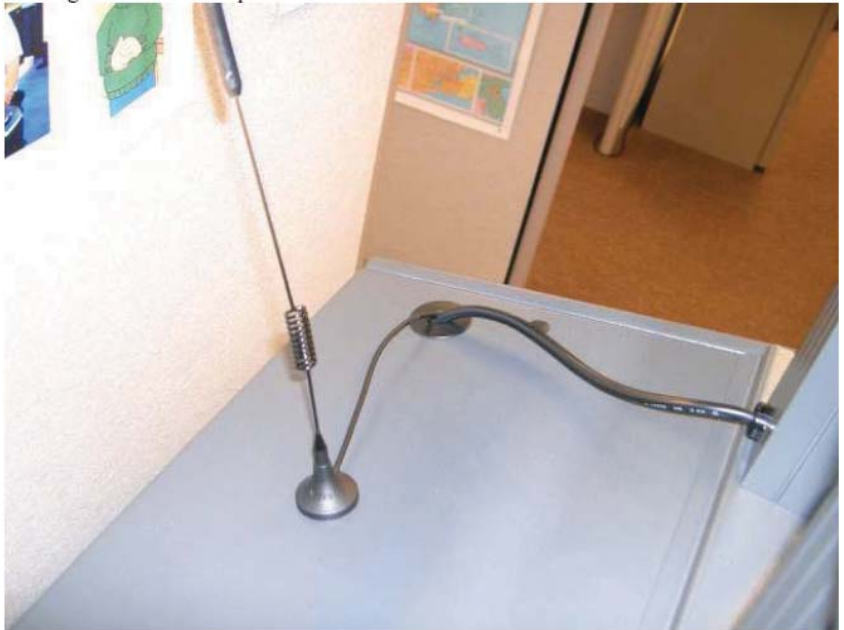
Mount the antenna to the outside of the cabinet as shown. The antenna cable is routed through the hole in the top of the cabinet.

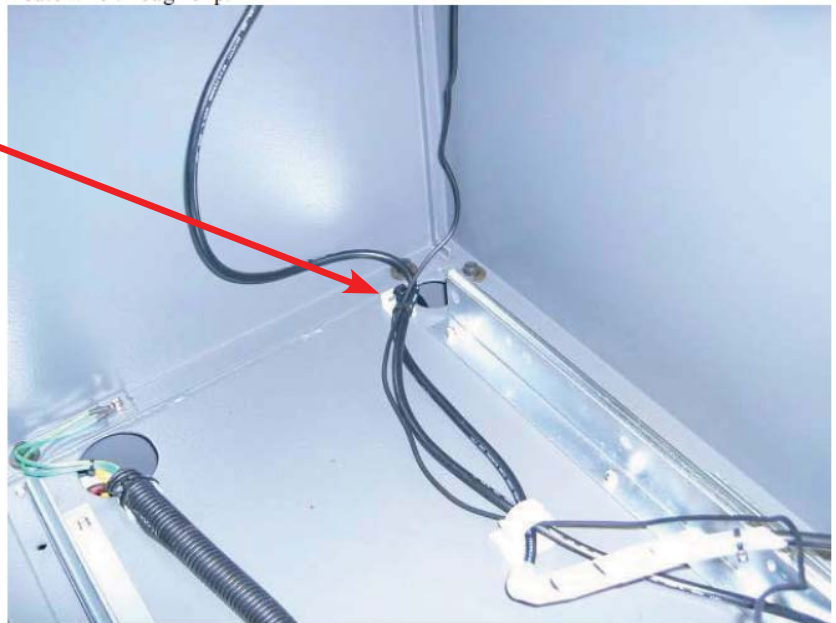
Zip tie the coax cable to the mount at the rear of the cabinet.

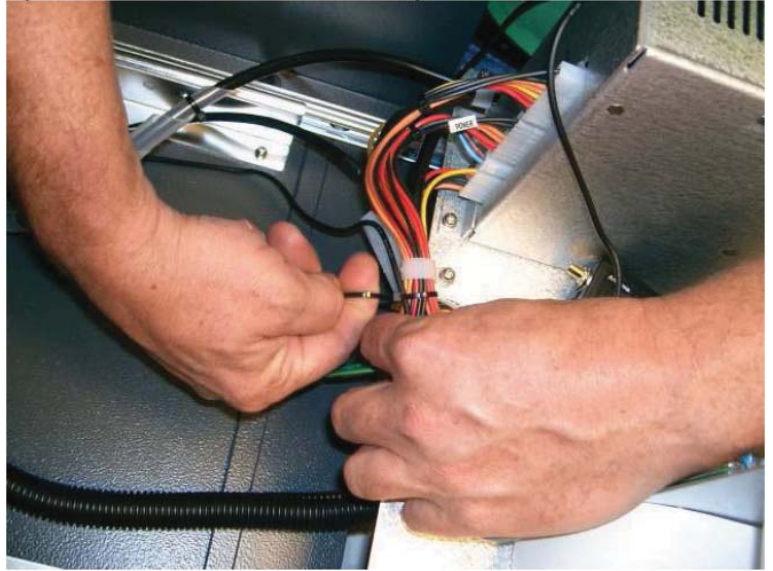
Zip tie the coax cable to the cable bundle on the tray.

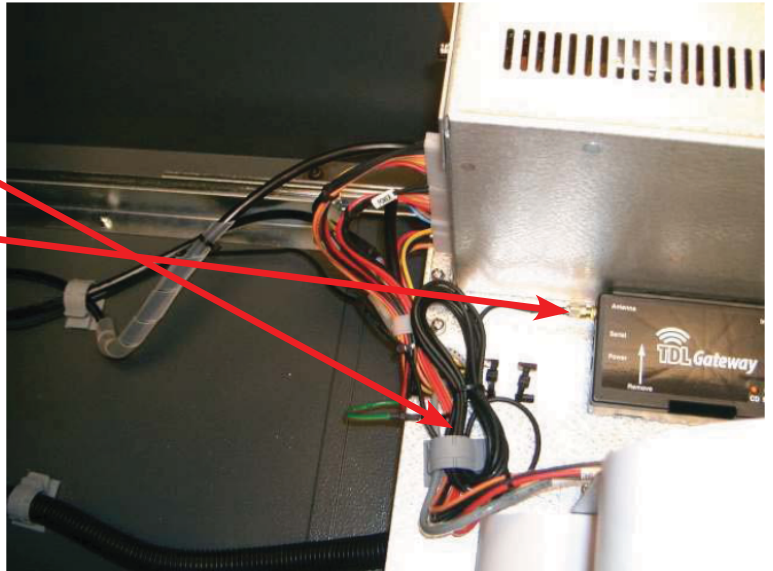
Bundle the excess antenna coax cable and place under the clip on the tray. Screw the antenna cable connector onto the TDL.

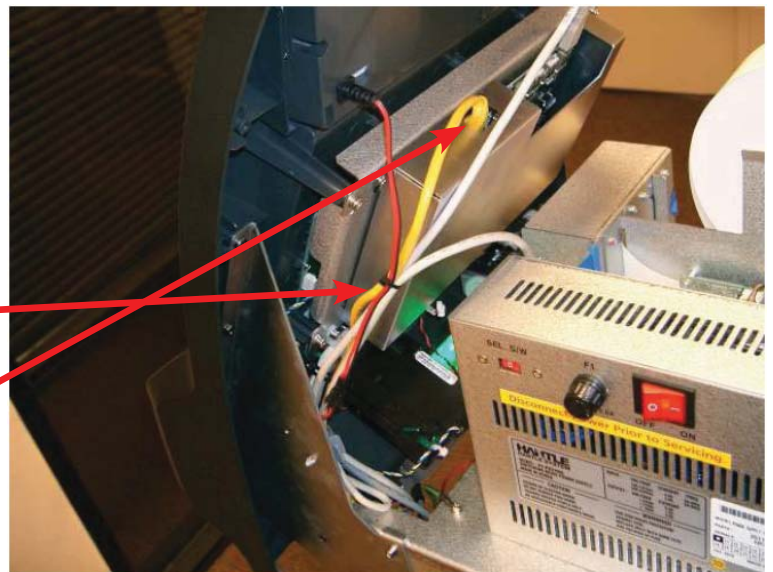
X2 - route the USB cable from the WM. to the Main Board and connect. Ensure the cable does not interfere with the opening and closing of the upper cabinet. Zip tie USB cable to the LED backlight power cable.

UNPLUG THE YELLOW ETHERNET CABLE FROM THE MAIN BOARD!

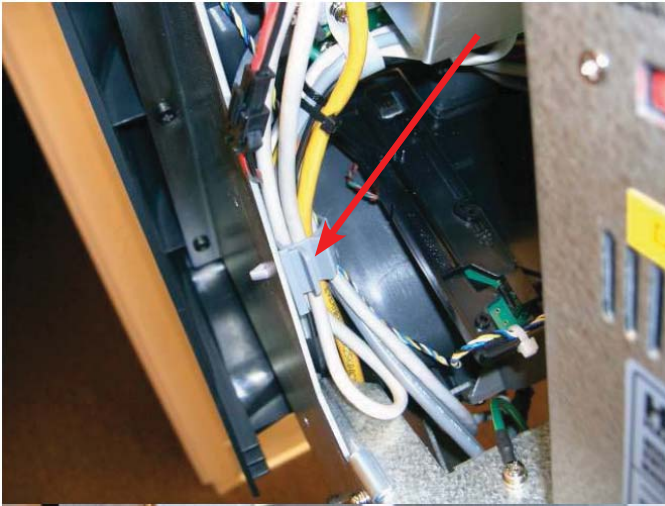
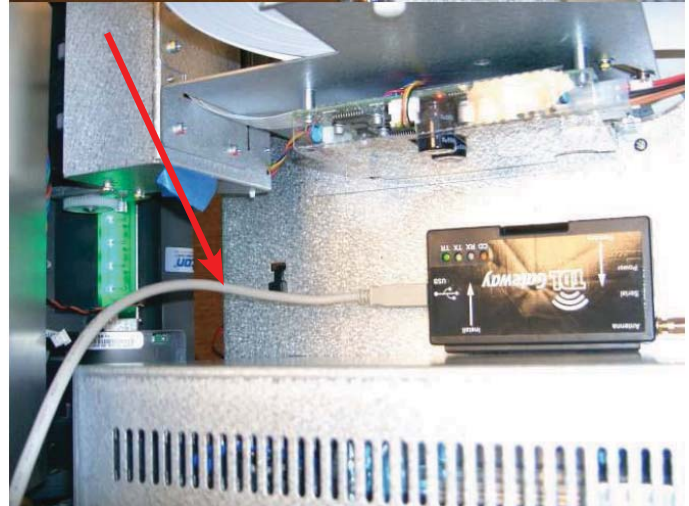
Route the USB cable under the clamp.

Ensure there is enough slack to allow the front panel to open and tilt down.

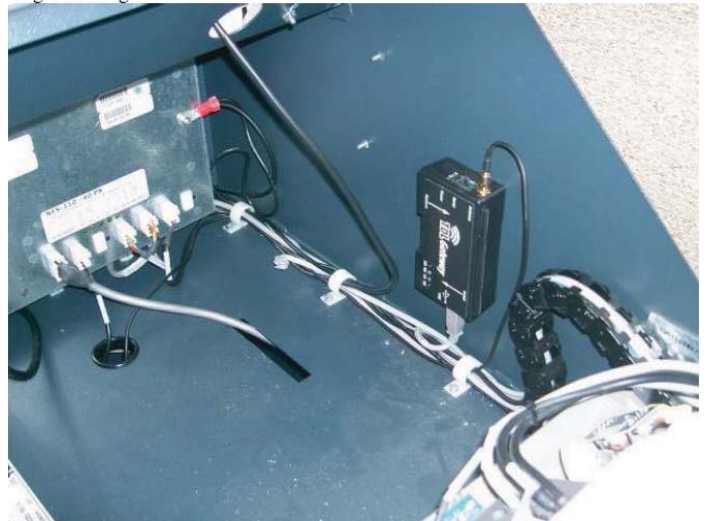
The WM is mounted on the right side (RL1600) , or on the roof of the cabinet (RL2300), on the studs provided

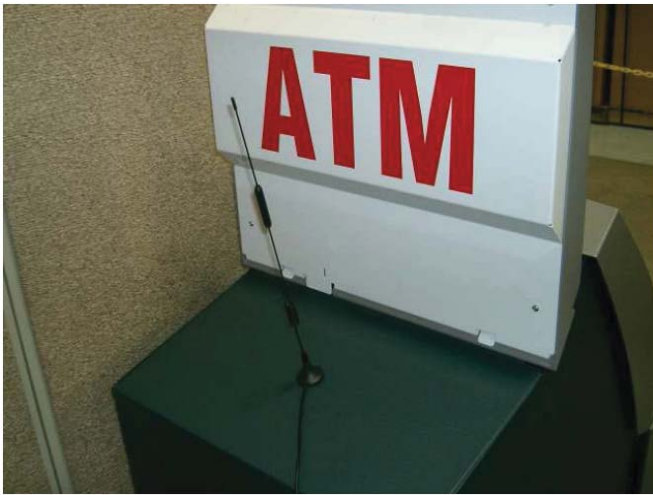
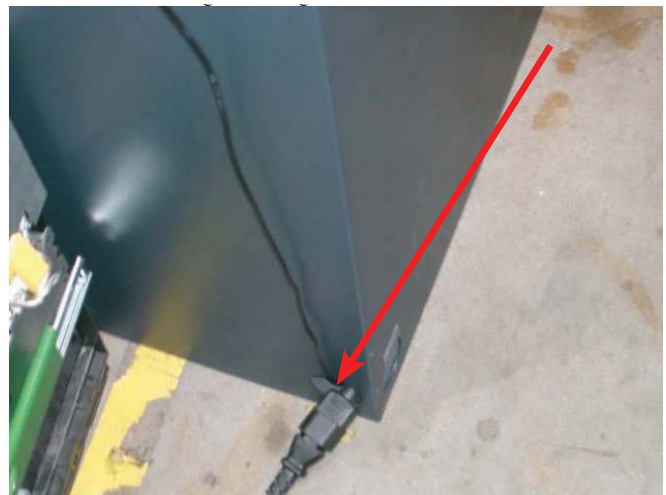
Mid Topper - Mount the antenna to the outside of the cabinet as shown. The antenna cable is routed through the hole in the bottom of the cabinet.

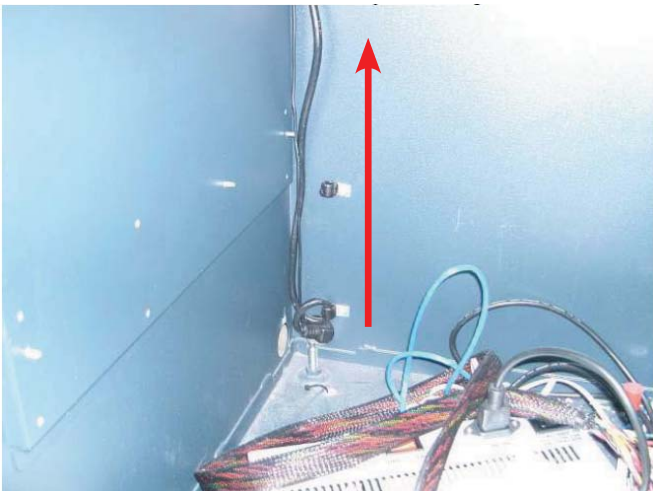
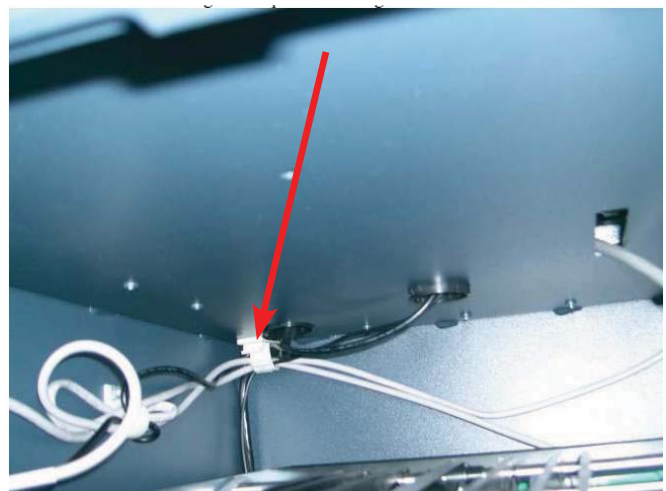
Route the cable up to the ceiling of the cabinet and through the clip.

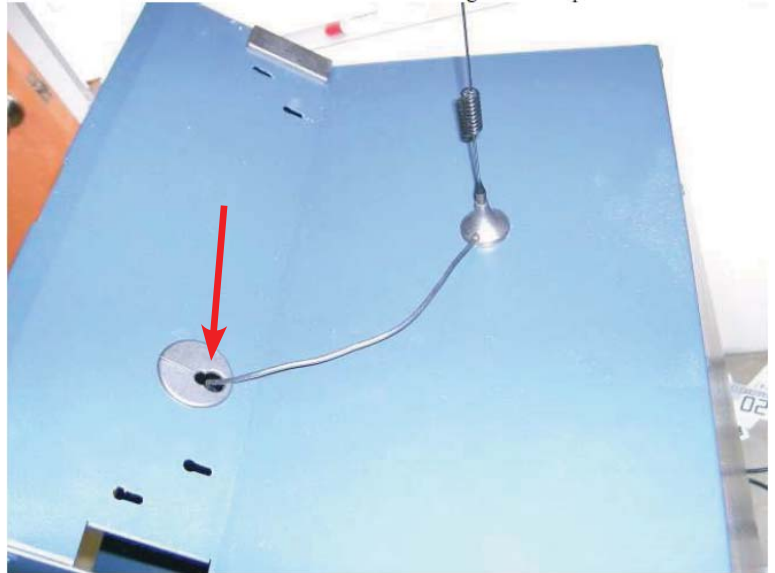
High Topper or no Topper -
Route the antenna cable
through the hole in the top.

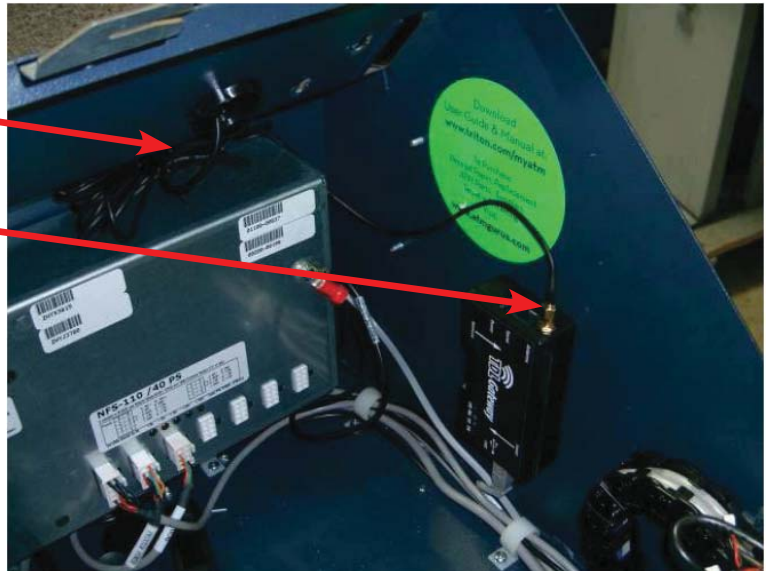
Bundle the excess antenna
coax cable and place on top
of the power supply..
Screw the antenna cable con-
nector onto the WM.

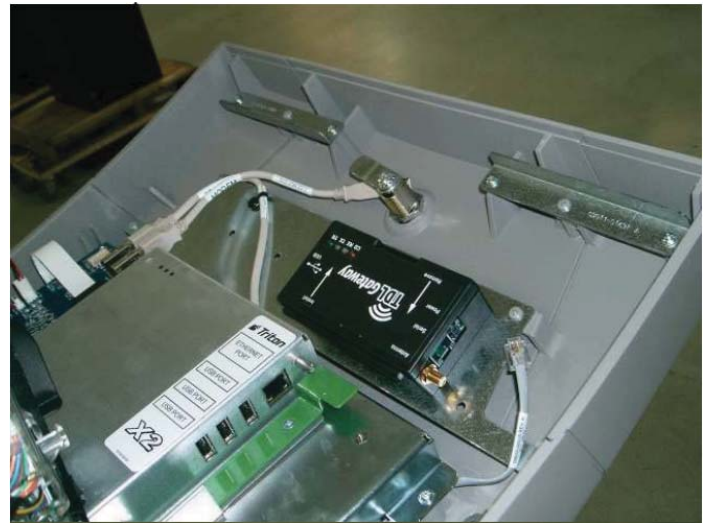
3. **WM:**
The WM is mounted on the control panel, on the studs provided.

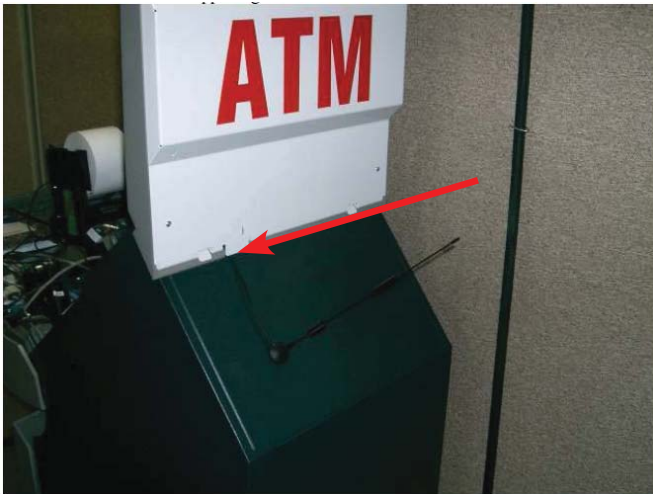
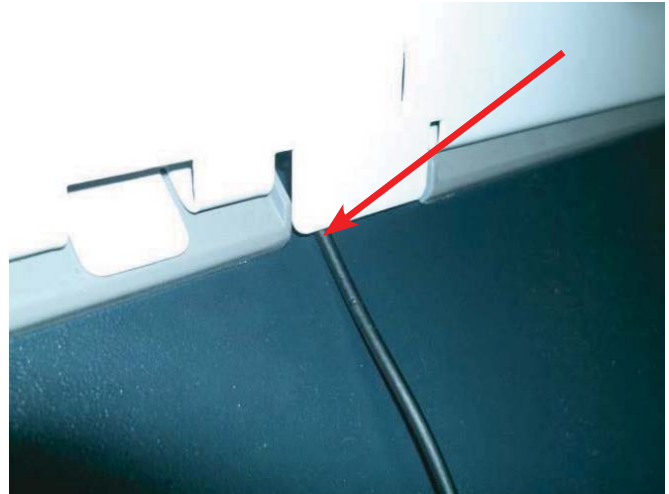
Mid Topper - Mount the antenna to the outside of the cabinet as shown. Remove the mid-topper sign and route the cable under the tab and down through the hole, Reinstall the mid-topper. Ensure the topper does not pinch or cause fraying of the cable.

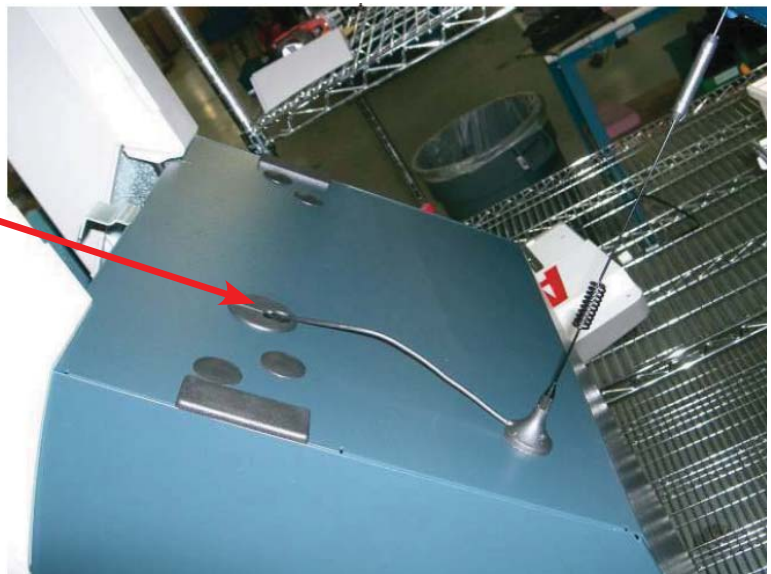
High Topper or no Topper -
Route the antenna cable
through the hole in the top.
Install grommet.

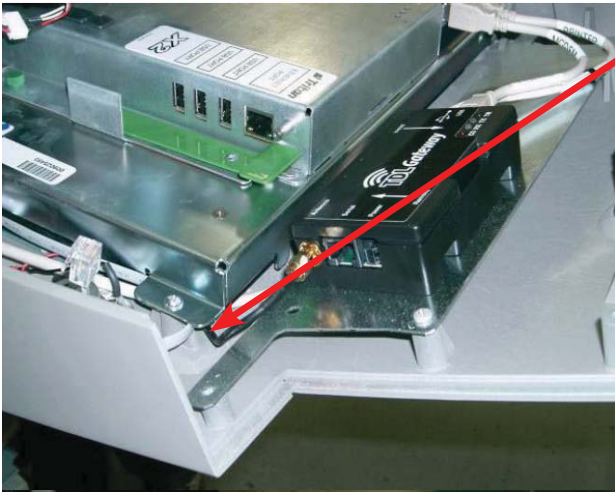
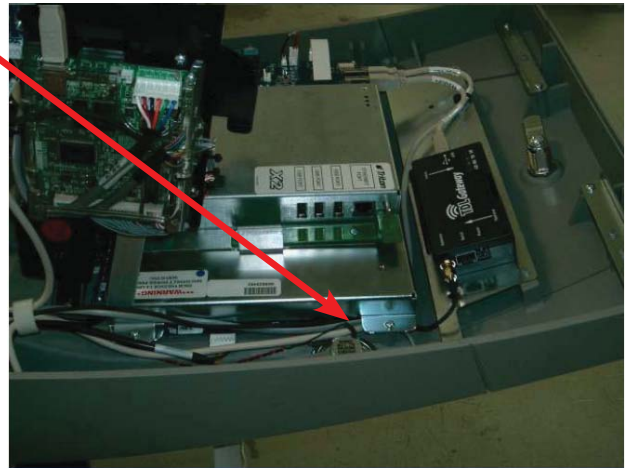
Connect the antenna cable to the WM. Route the cable under the LCD boss.

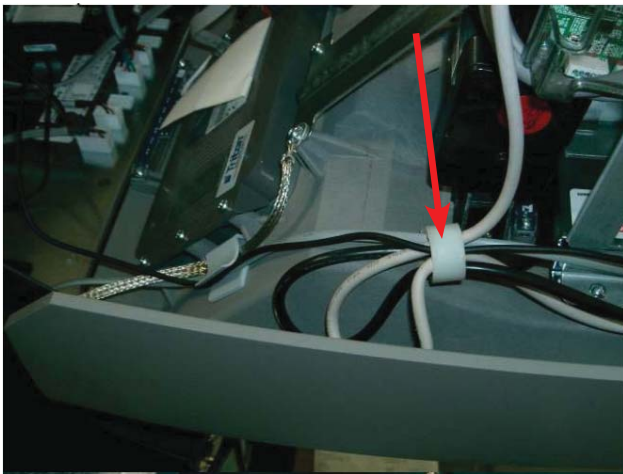
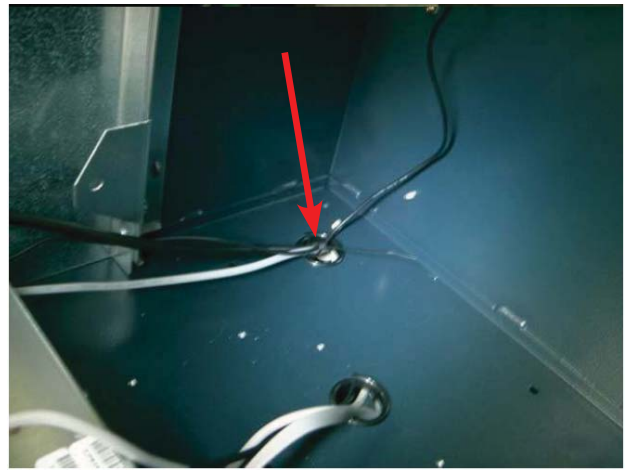
Continue routing through the two clips on the control panel and to the rear of the cabinet. Zip tie the coax cable to the wire bundle at the back left corner.

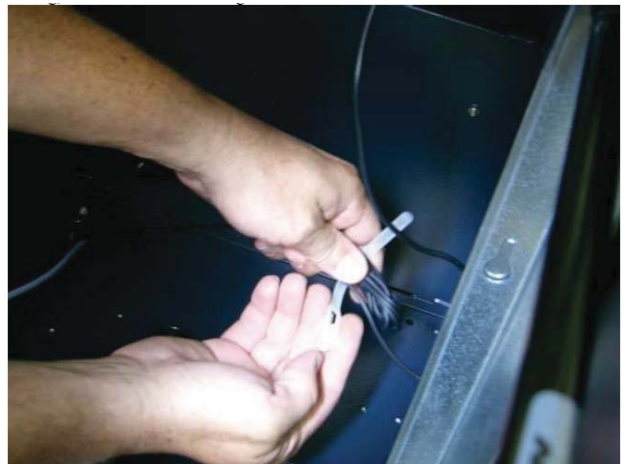
Bundle excess cable. Zip tie with captive mount. Insert into the hole in the corner. Ensure there is enough slack to allow the front panel to open.

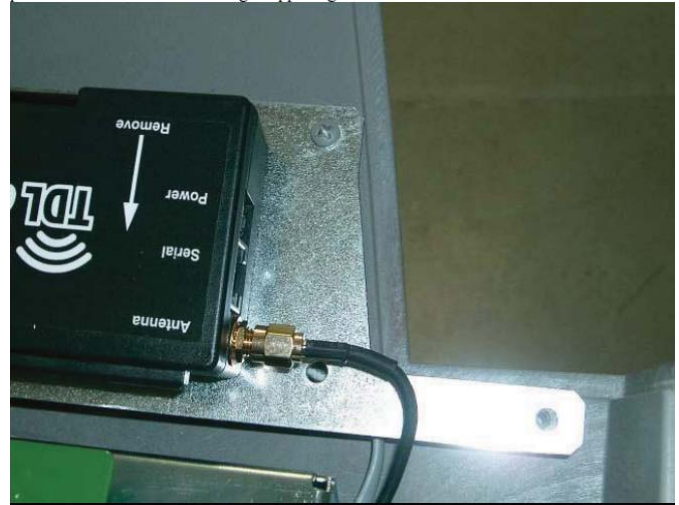
NOTE:

Ensure there is no excess cable in this area that could be pinched with the control panel on units with high top-per signs installed.

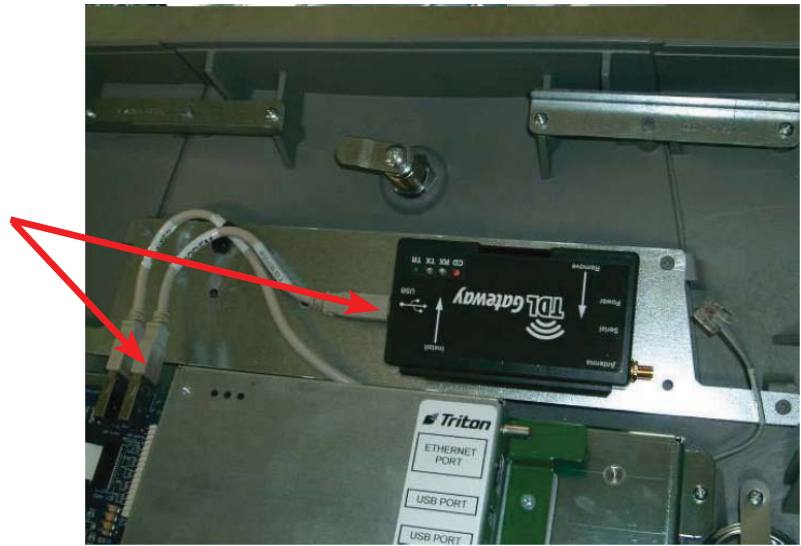
X2 - route the USB cable from the WM. to the Main Board and connect. Ensure the cable does not interfere with the opening and closing of the upper cabinet. If there was a cable used for the Telephone modem, it can be used again.

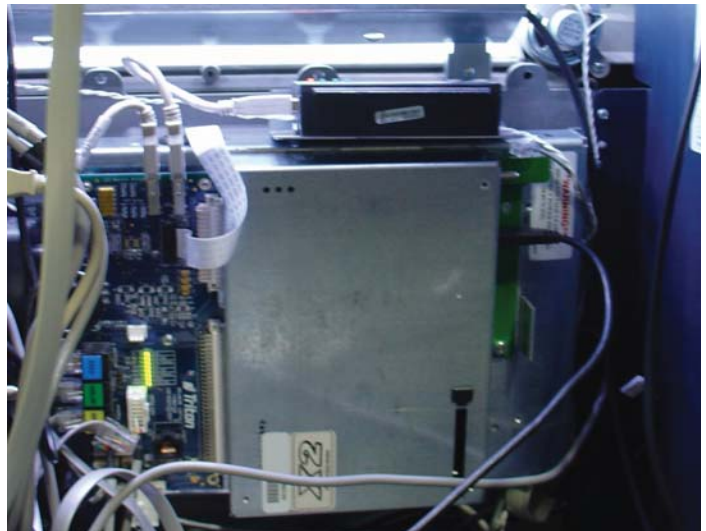
The WM is mounted on the top of the main board enclosure, in the telephone modem bracket. If the bracket is not present, the double sided tape may be used.

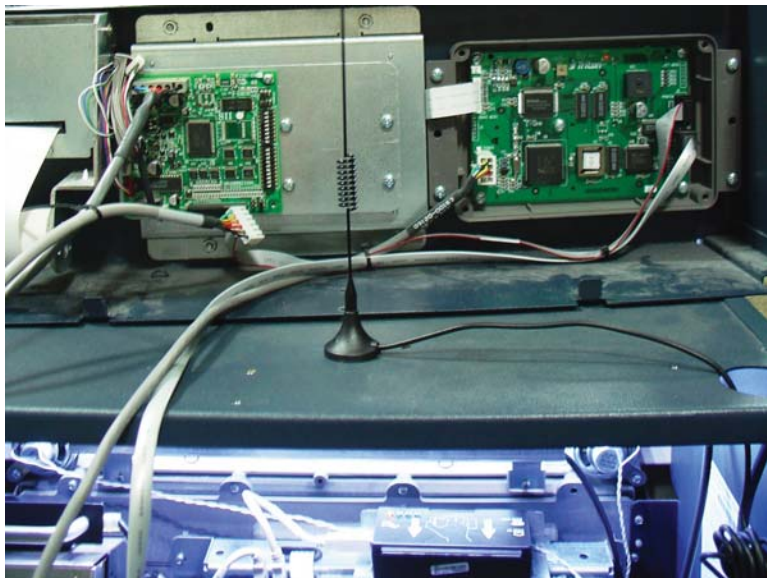
Mount the antenna to the top of the cabinet. Route the cable through the hole. The RT2000 may not have an access hole. Drill a 7/16" hole in the right corner of the cabinet, much like the FT5000 shown. Ensure you miss the mounting bracket for the Rear Service Panel. Be very careful of the metal shavings from the drilling process. Do not allow them to fall into any electrical components.

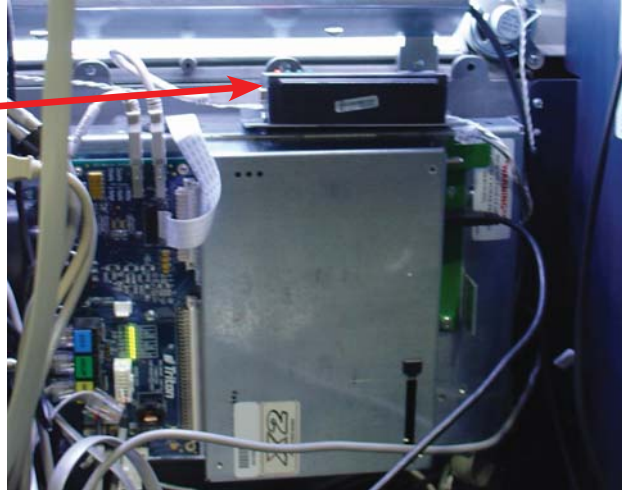
Connect the antenna cable to the WM.

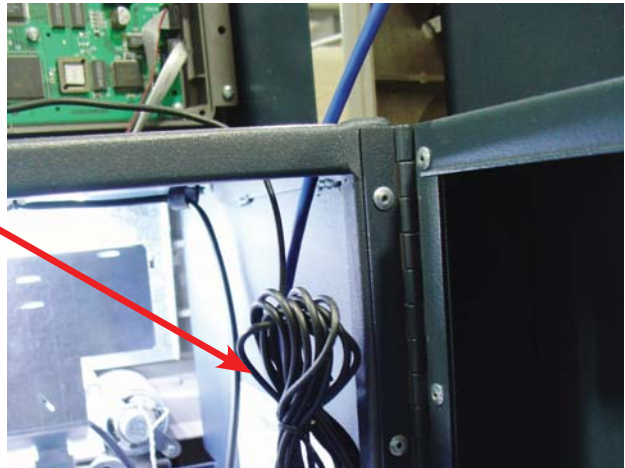
Bundle the excess cable and tie wrap.

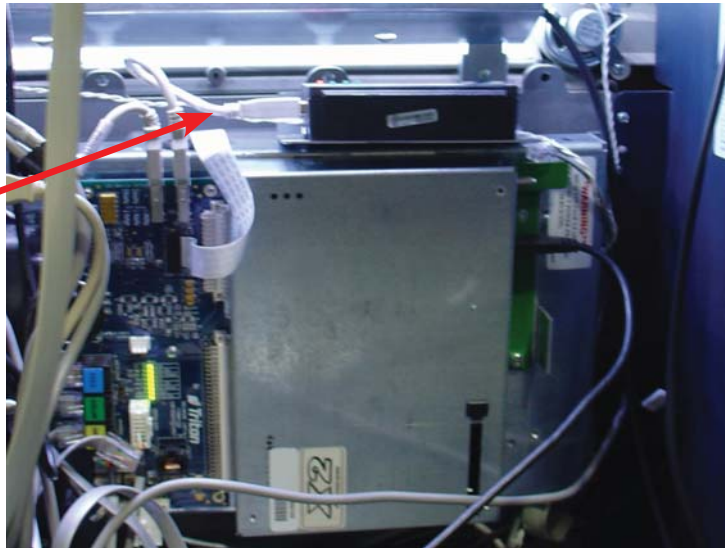
X2 - route the USB cable from the WM. to the Docking Board and connect. If there was a cable used for the Telephone modem, it can be used again.

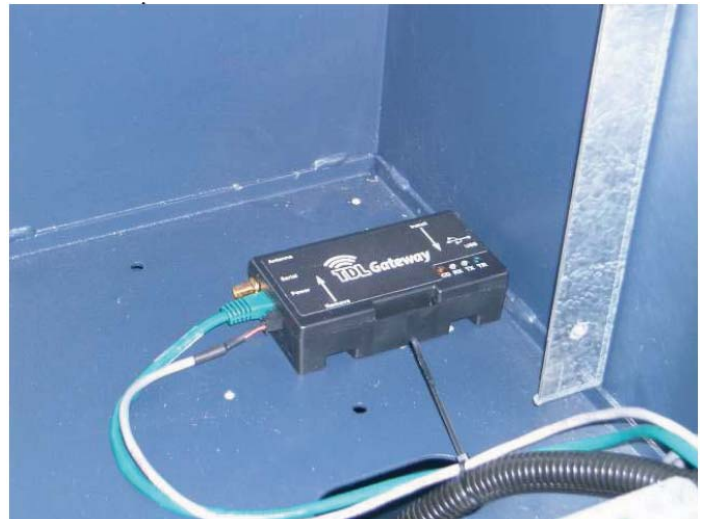
The WM is mounted with double sided tape to the back right corner.

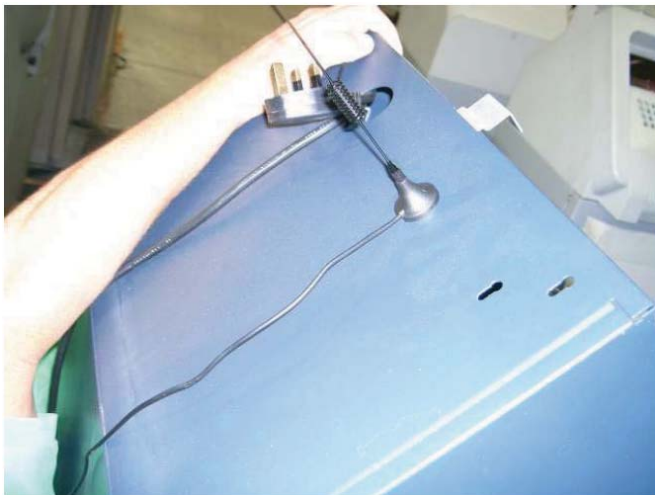
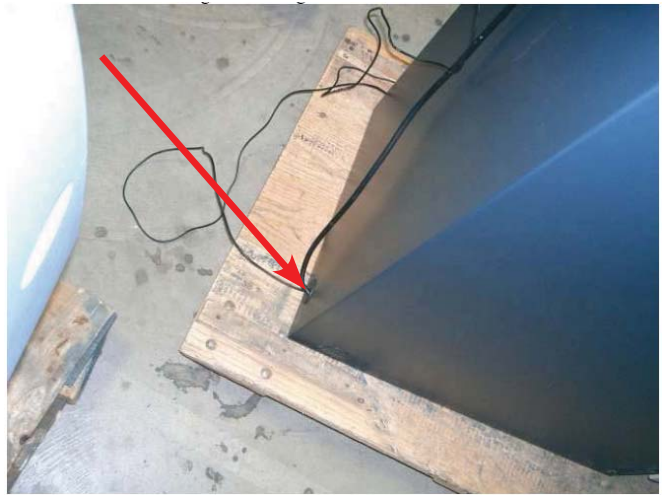
Mid Topper - Mount the antenna to the outside of the cabinet as shown. The cable routes to the bottom of the cabinet. Route through the hole with grommet.

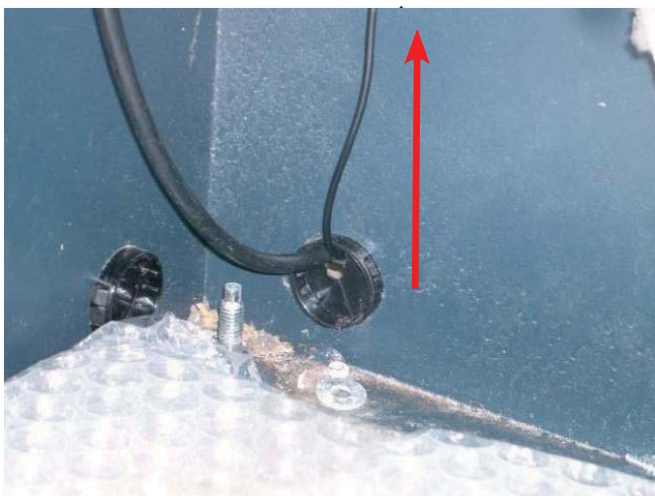
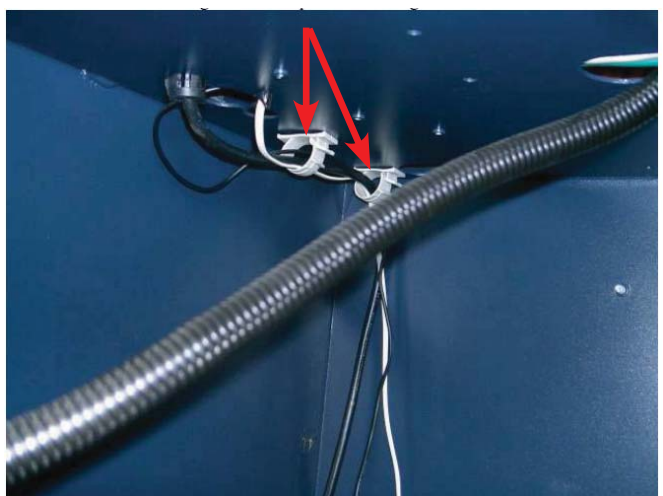
Route the cable up to the top. Route through the two clips on the ceiling.

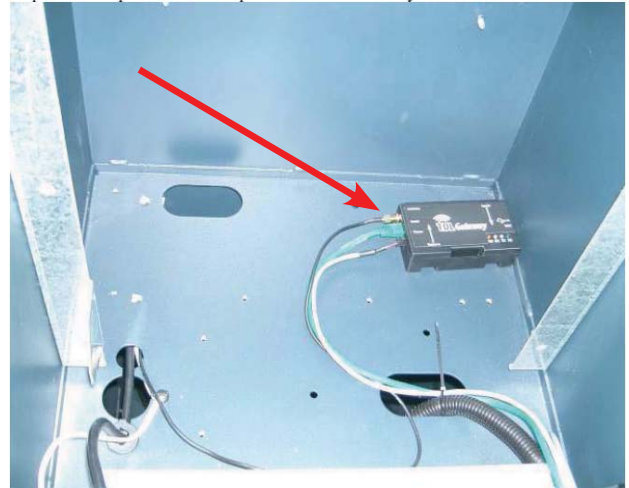
Route the cable up into the upper cabinet.

Connect the antenna cable to the WM.

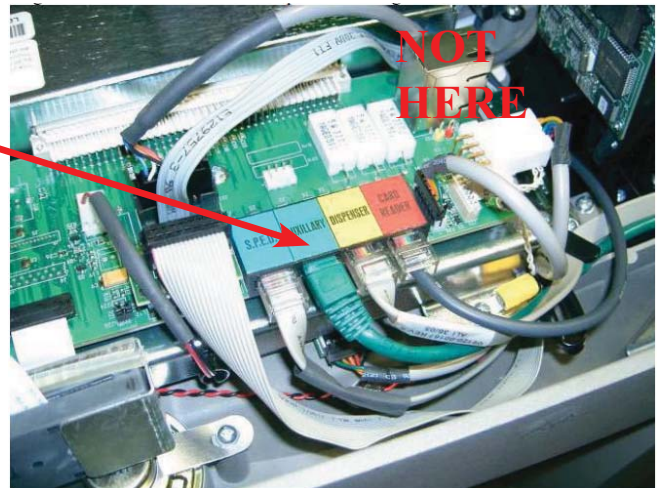
Connect the RS232 serial cable (Green) to the Auxiliary port on the docking board. This cable resembles an Ethernet cable, but is not. DO NOT be tempted to connect it to the Ethernet port on the docking board.

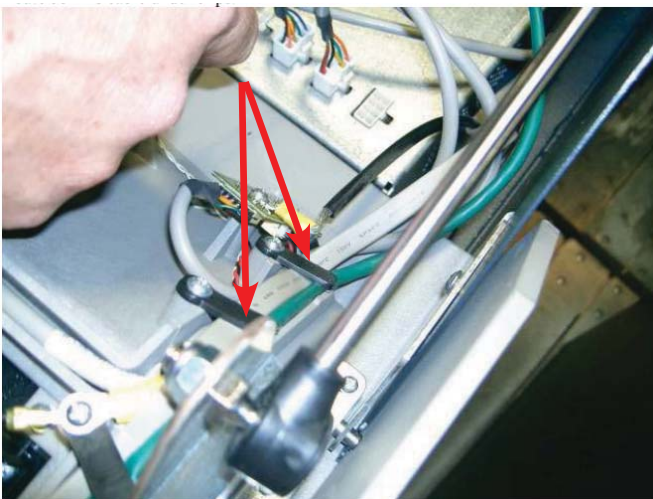
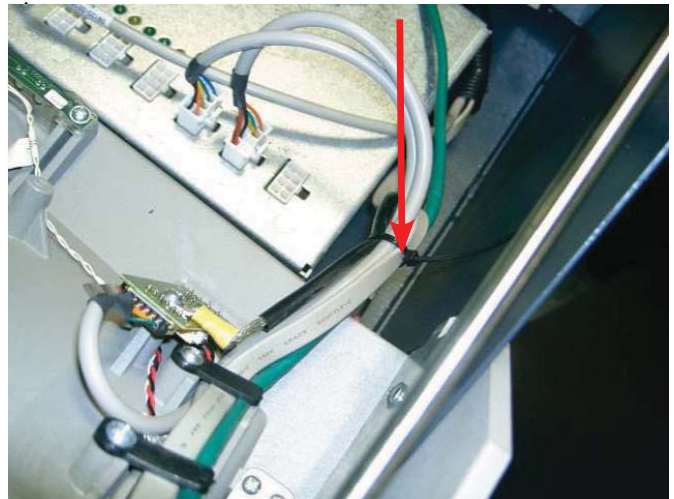
Route the comms cable under the clips. Zip tie to the cable bundle.

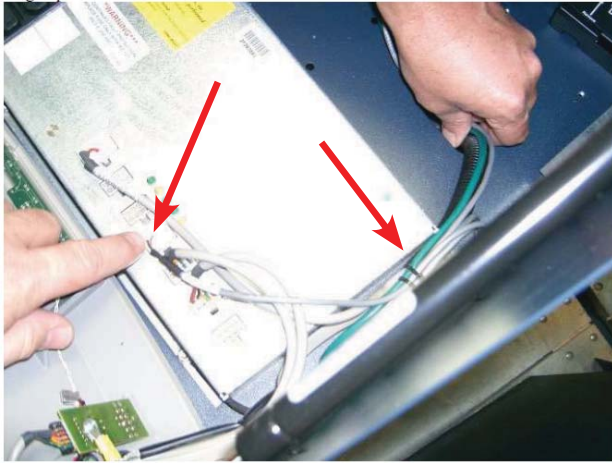
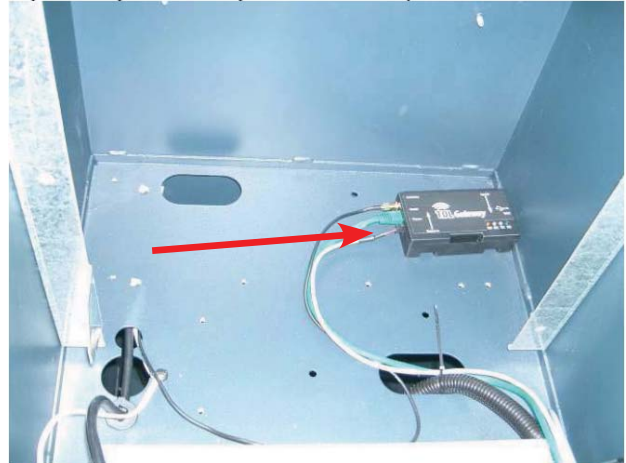
Connect the power cable to an open connection on the power supply. Zip tie the comms and power cables to the wire bundle. Connect the comm and power cables to the WM.

Snip off excess from all zip ties. Ensure the WM is secured to the cabinet with the double sided tape.
