TECHNICAL BULLETIN

SUBJECT:
RELEASE OF SCDU III

TECHNICAL BULLETIN: 16-15
DATE: NOVEMBER 03, 2016

TRITON ANNOUNCES THE NEW SCDU III WITH INTEGRATED MAIN BOARD AND ULTRASONIC DOUBLE-DETECT SENSORS FOR ARGO AND TRAVERSE.

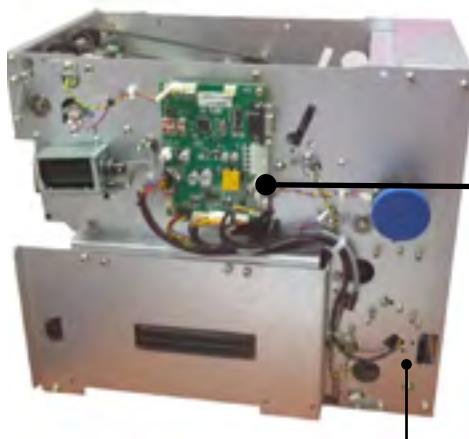
Separate
double-detect
board no longer
needed

Integrated main
board with
double-detect
functionality
built in

Triton announces the new SCDU III with an integrated main board and ultrasonic double-detect sensors. The new main board, which has the double-detect functionality built in, is backwards compatible for use on existing SCDU dispensers with a double-detect board and white double-detect sensors. The new, black ultrasonic double-detect sensors IV are only compatible with the new SCDU III integrated main board.

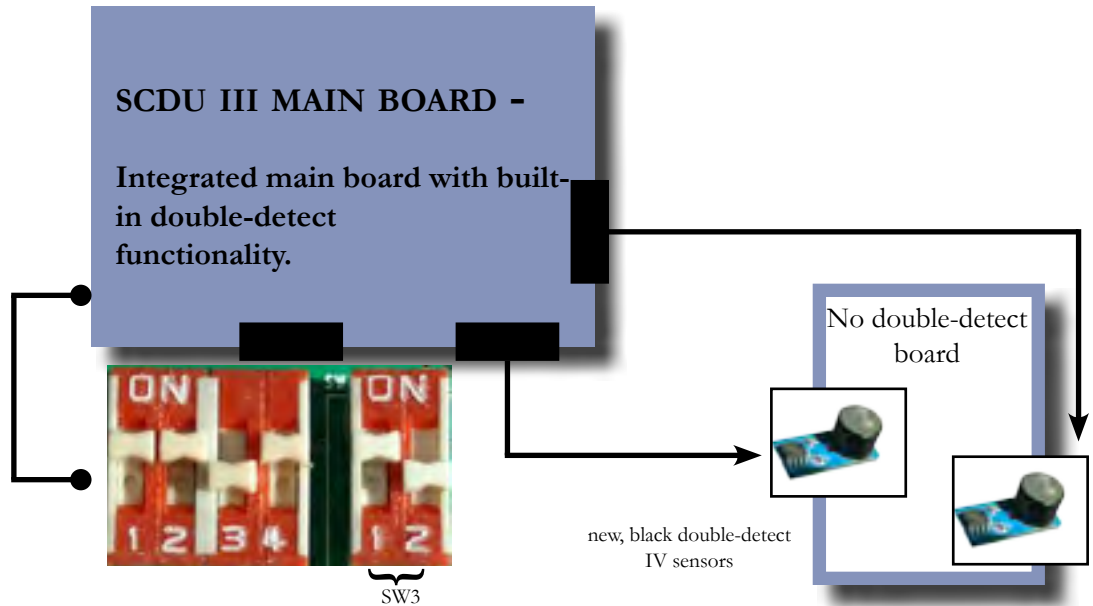
Option 1:

SW3 No. 1 position should be ON (up) for new, black sensors on SCDU III. When used with the previous, white sensors, SW3 No. 1 position on the new main board and SW1 No. 1 position on the double detect board should be OFF (down).

SCDU III

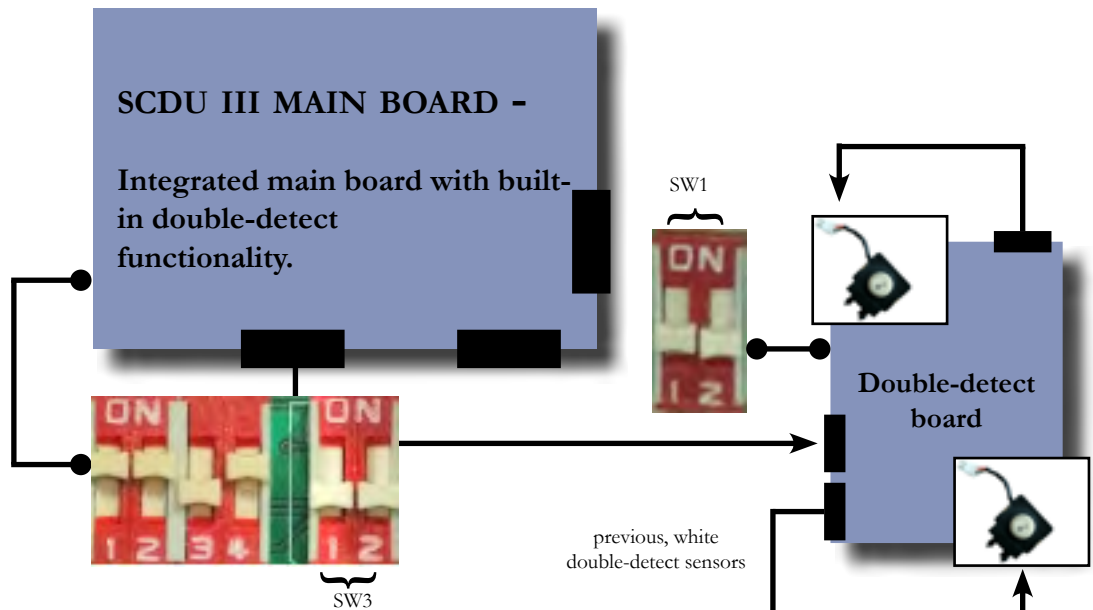
Option 2:

SCDU III main board is backward compatible for use with SCDU II double-detect board and large, white double-detect sensors.
